April 22, 2004

**RE: Pre-demolition Asbestos Inspection for former Inno Tech Industries located at 154 Olive Street in Elyria, Ohio 44035**

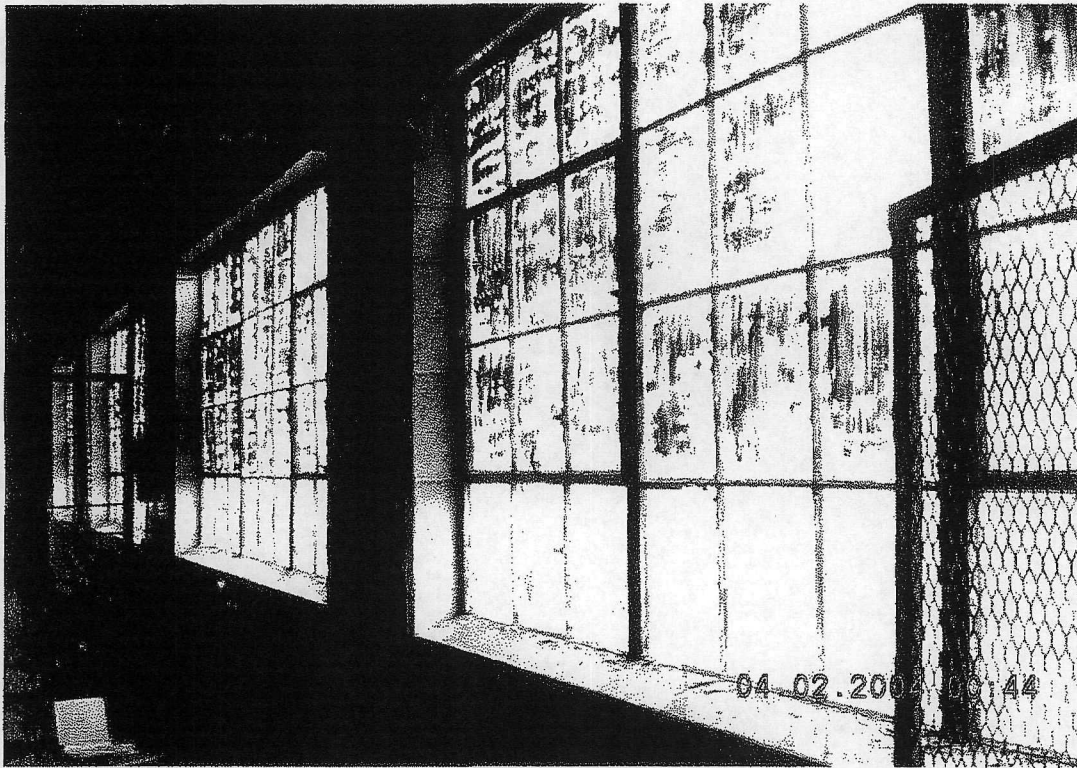
This photo is taken of the windows on the second floor. Samples from the caulking were found to contain no asbestos

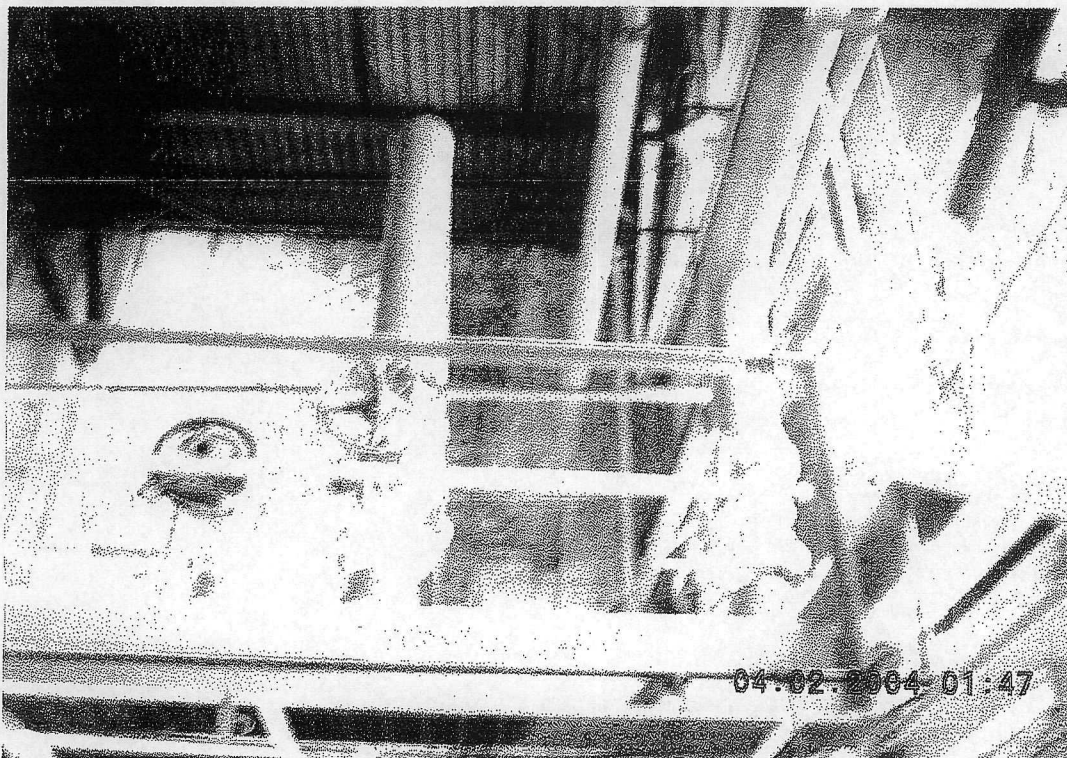
Orange piping insulation around the area of the boiler room was sampled and found to contain asbestos.

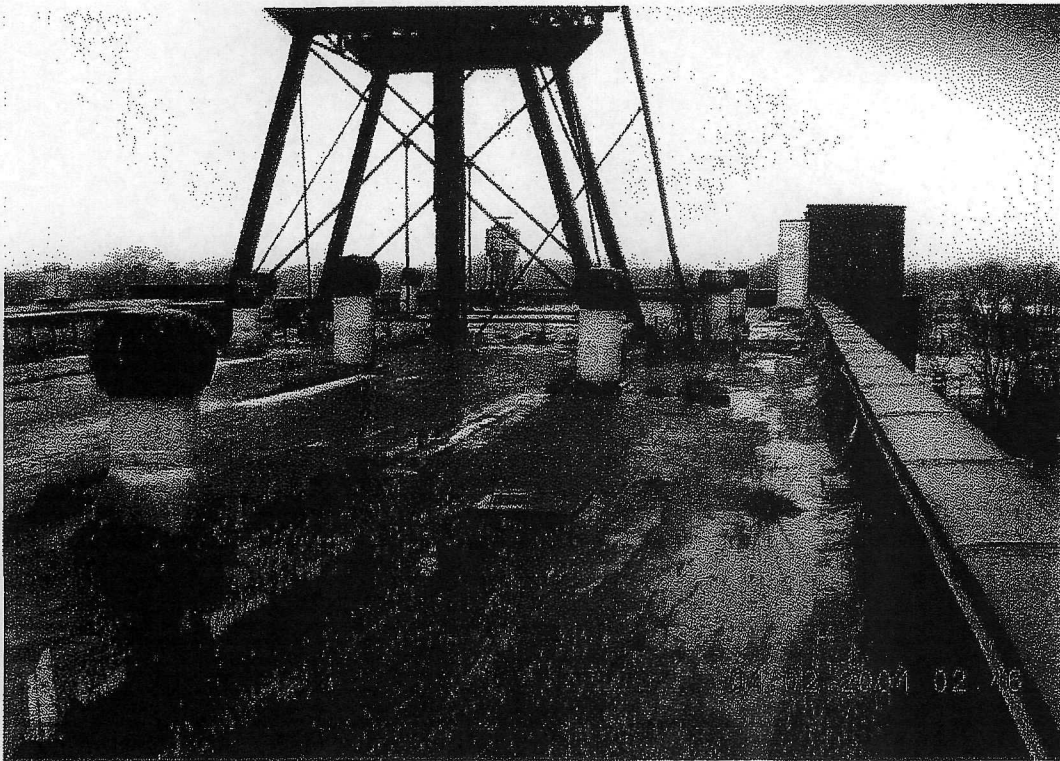
This is a photograph of the roof. None of the materials tested contain asbestos

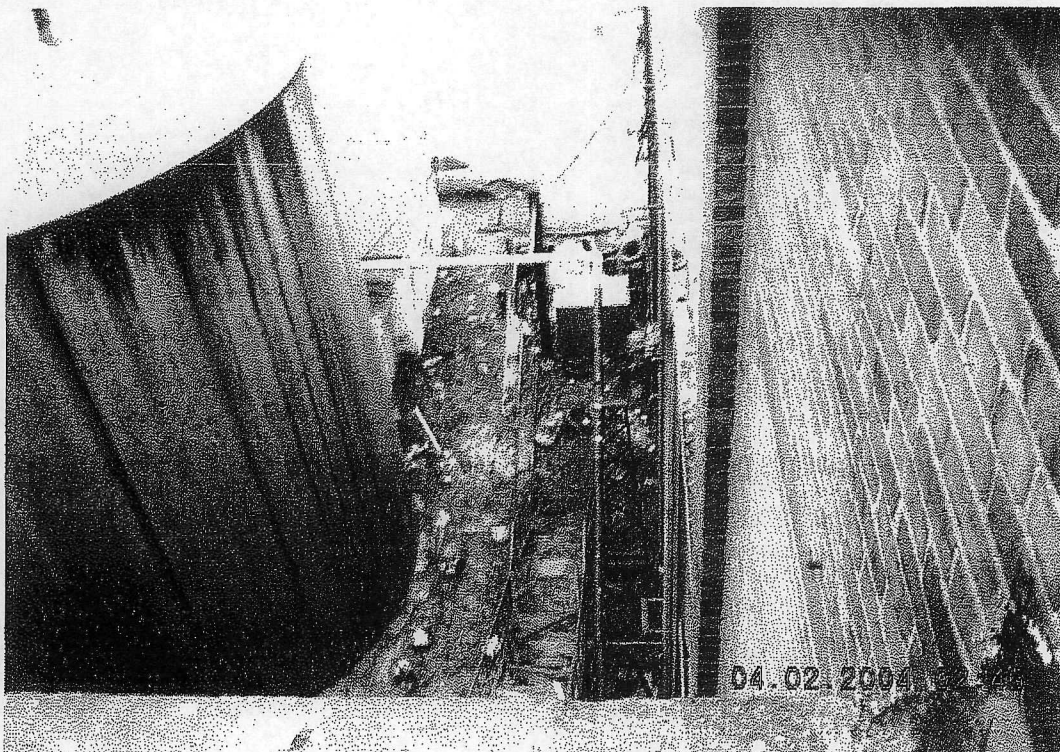
This shot is looking down on another pipe run. The insulation tested here did not contain asbestos.

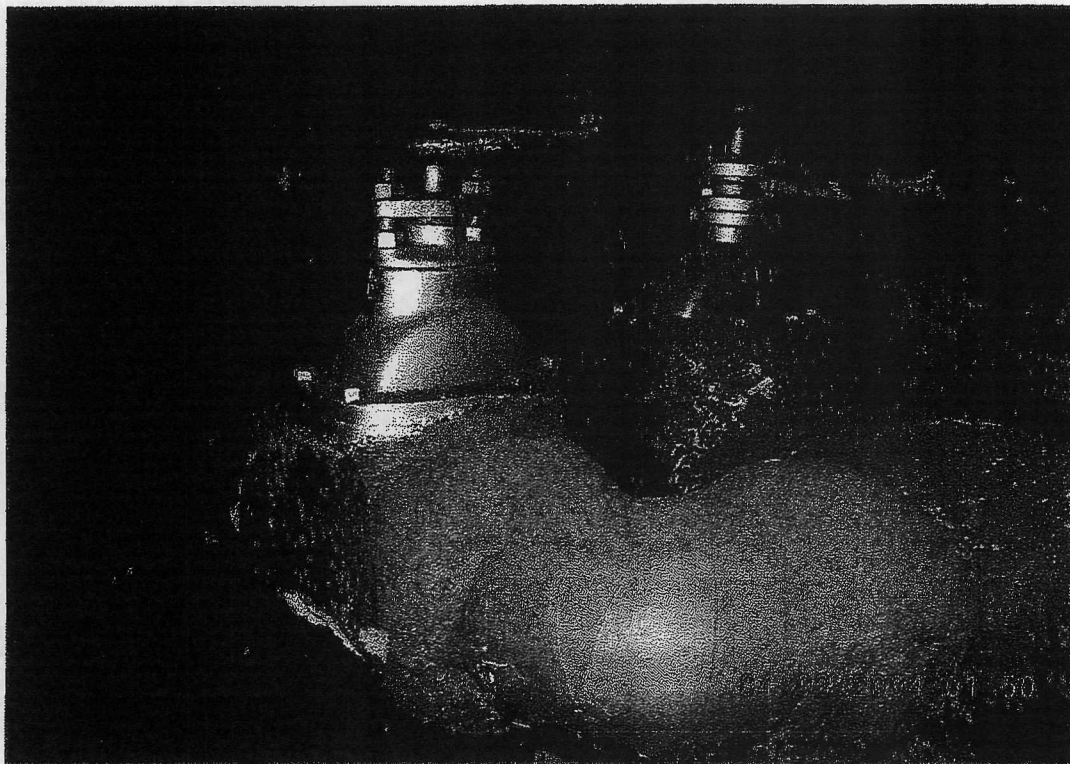
More orange piping insulation. This is found under the floor in the room adjacent to the boiler room. You can get there by going down the flight of steps in front of the mens restroom.

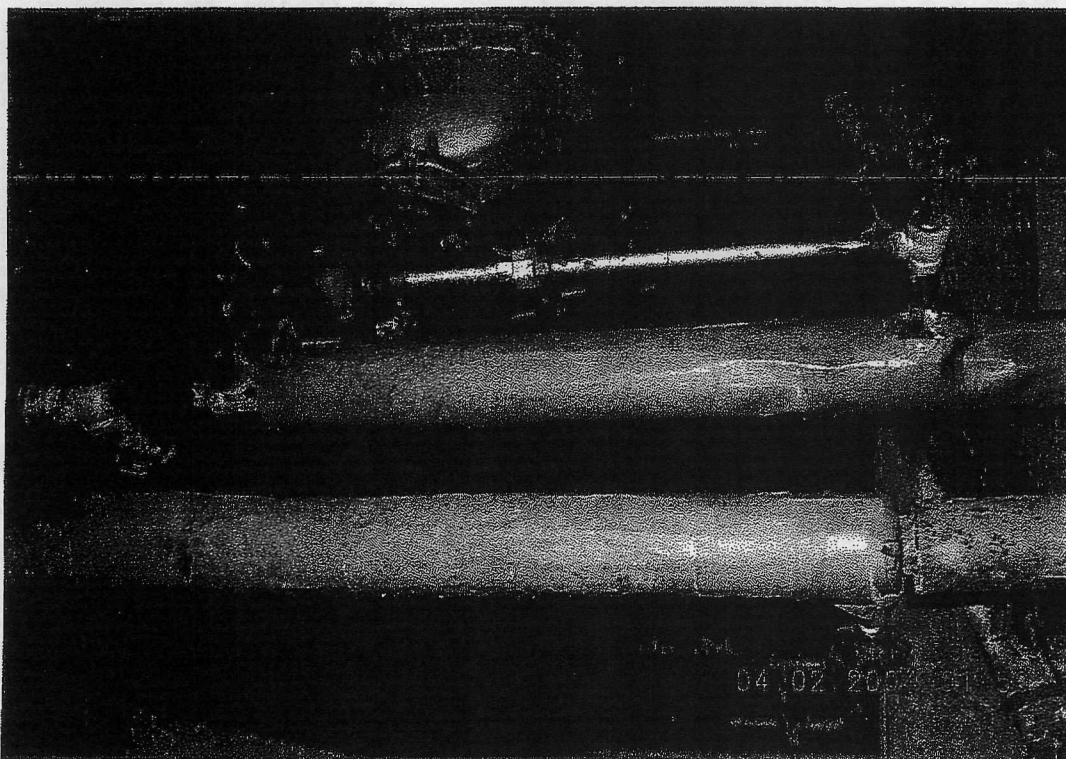
Another picture of the asbestos containing piping insulation.

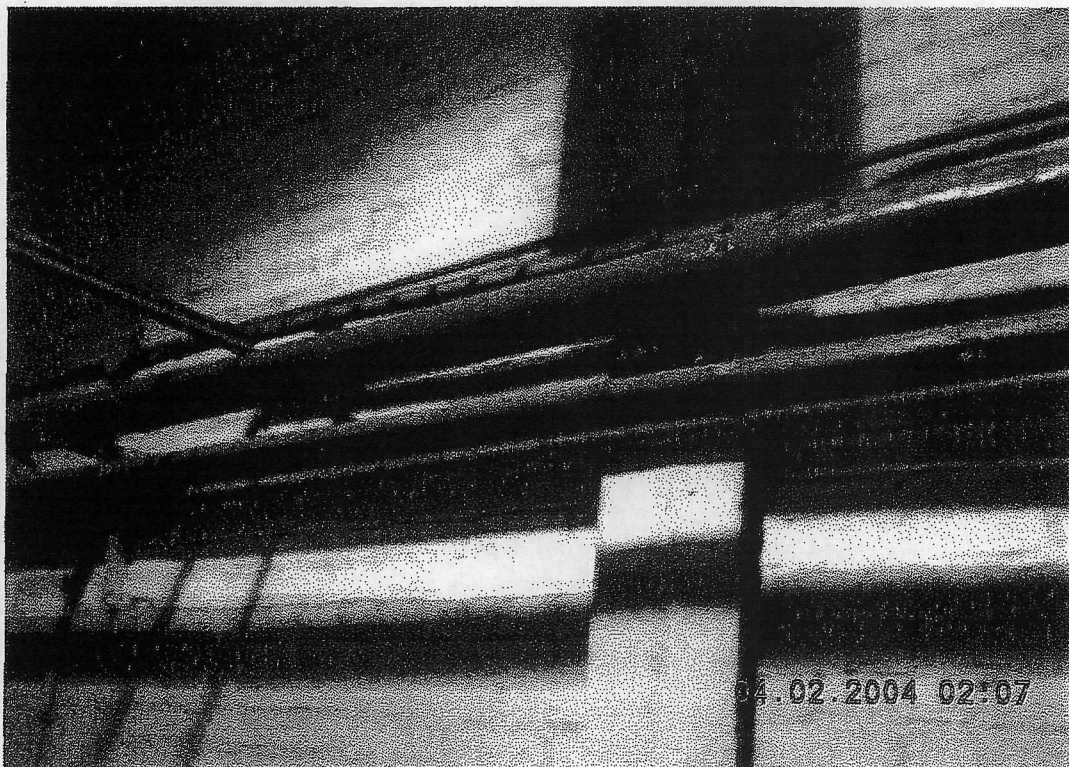
The green and red pipe here were also found in the boiler room. Samples collected from them indicated that they do not contain asbestos.

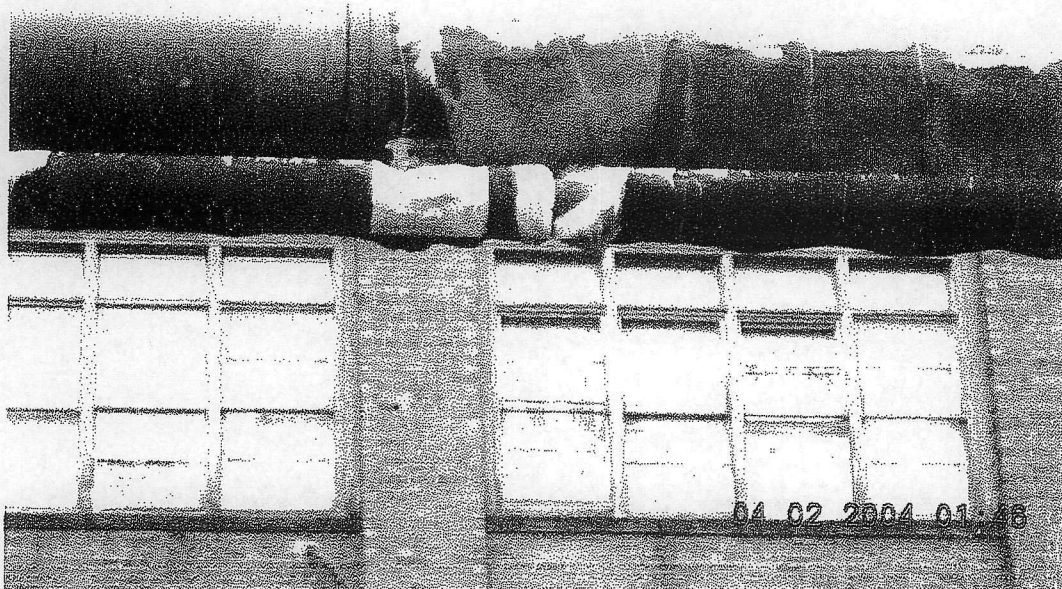
This is a photograph of the two pipe runs located in the courtyard area. Both of them were tested and contain asbestos in the insulation.
